<b>Subject:</b>  FRONT BRAKE SQUEAK WHEN COLD	<b>Bulletin No:</b> 04-007/06
	<b>Last Issued:</b> 9/1/2006

2004-2006 Mazda3

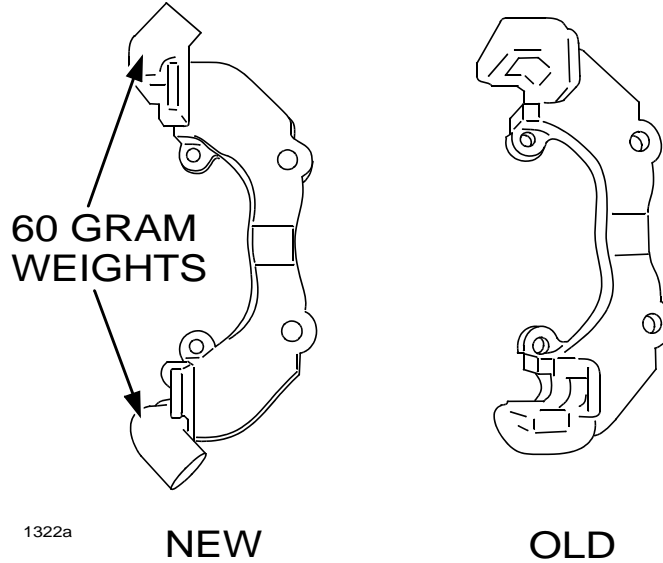
When applying the brakes during slow speed driving and in cold weather conditions, some vehicles may have a squeak noise coming from the front brakes. This may be caused by resonance in the pad, disc, and caliper.

- If service bulletin 04-001/05 was already performed on this vehicle, the updated caliper mounting supports will already be installed. Verify that the updated supports are installed through visual inspection.
    - If updated caliper mounting supports are not installed, continue with REPAIR PROCEDURE "A".
    - If updated caliper mounting supports are installed, proceed to REPAIR PROCEDURE "B".
2. Replace front brake caliper mounting support assemblies and front pad & shim set with the modified parts

according to Workshop Manual (section 04-11 FRONT BRAKE (DISC) REMOVAL/INSTALLATION).

- Use new bolts 9975-60-230, two (2) per mounting support. The thread pitch is different than original. Do not reuse original mounting support and bolts.
