A.B.I SERVICE BULLETIN FOR CHRYSLER APPLICATIONS / BULLETIN DE SERVICE POUR LES APPLICATIONS DE CHRYSLER

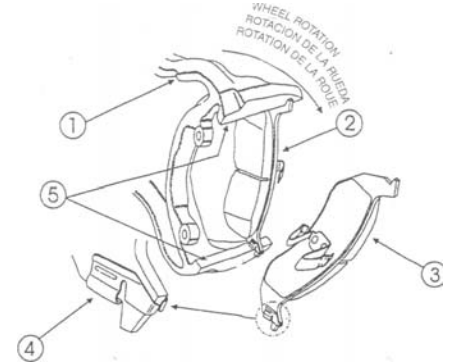
PROBLEM On these application brake noise may be caused by chatter, clunking and clicking may occur

CAUSE The anchor rail may be worn over time, creating excessive clearance between guide rails and pads

SOLUTION Install our ABI-H91984 reparation kit to reduce the clearance between the pads and guide rails

This kit contains universal abutment clips of various thickness to reduce clearance between the disc pad and the guide rails

- 1 - remove old pads and clean guide rails
- 2 - apply a thin film of moly lube to both guide rails
- 3 - install new ALCO pads with appropriate size abutment clip to reduce between pad and guide rails
- 4 - always attach clips on the trailing edge of the pad

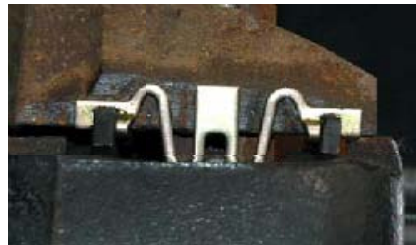
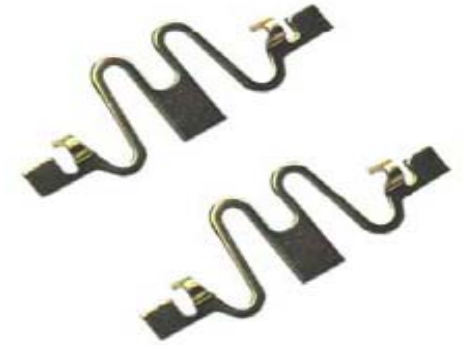
PROBLEM brake noise and brake not returning to their position properly

CAUSE not reinstalling or non replacement of return clips

the spring clips will help the pads to return to their resting position. Often omitted after pad service, the clips are not installed.

SOLUTION installing ALCO repair kit H-D591

We recommend installing/replacing the clips every time front pads are serviced for optimum braking performance
